Subject: (Volt) High Voltage Drive Motor Battery TAC Restriction and Exchange Program

Models: 2016-2017 Chevrolet Volt

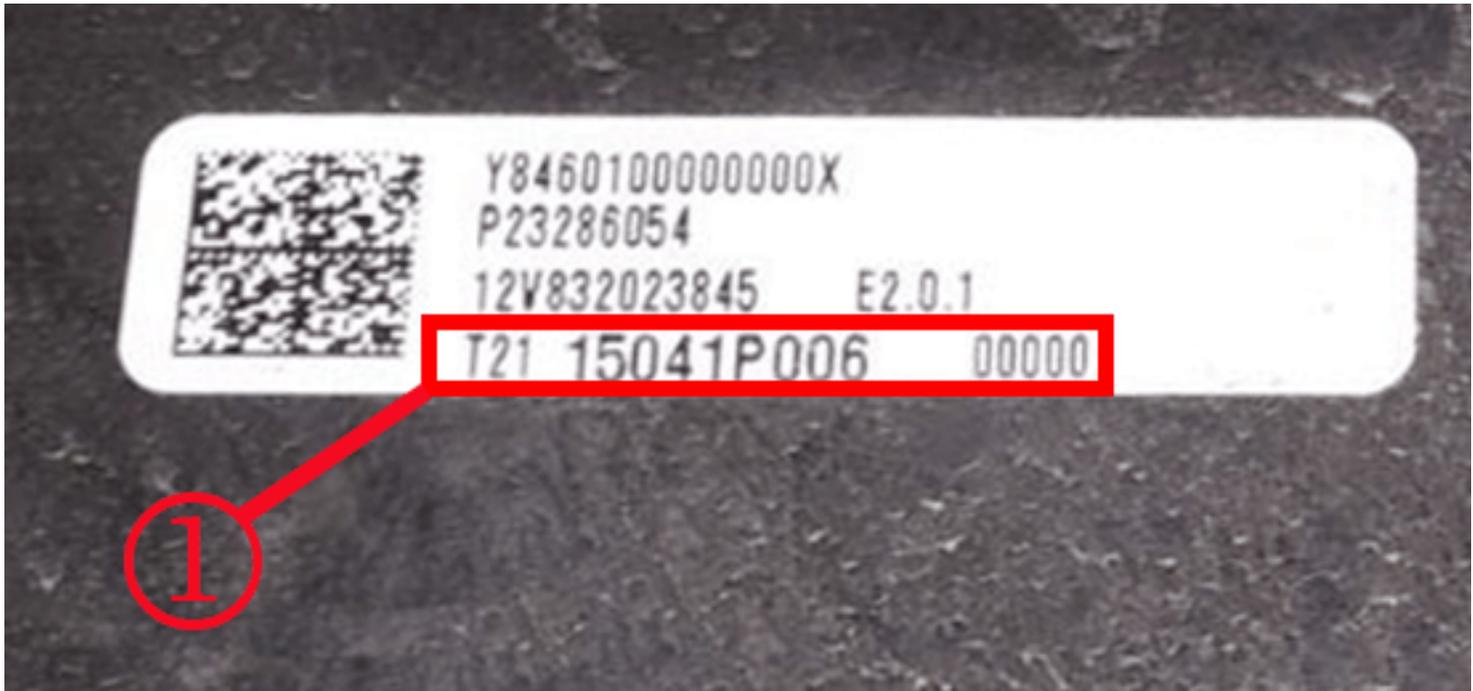
- 6.2 The battery has a battery identification tag that is located on the right side of the battery. Locate the tag and record the 16 digit battery identification number (BIN). The BIN is the bottom most number on the label and it starts with a "T" indicator (See Photo Below). If the battery is not out of the vehicle yet, you can find the BIN by installing the MDI and using GDS 2. Access the Battery Energy Control Module and look under the identification information section and the sixteen digit number will be listed under the parameter: Hybrid/EV Battery Pack Identification Number
